*Effect of Aging on Discharge Tolerance of
Grouted Solar Array Panels
Confirmed by Simulated Space Environment*

Taishi Endo, Tomohiro Wada, Hirokazu Masui,
Kazuhiro Toyoda and Mengu. Cho
Laboratory of Spacecraft Environment Interaction Engineering
Kyushu Institute of Technology

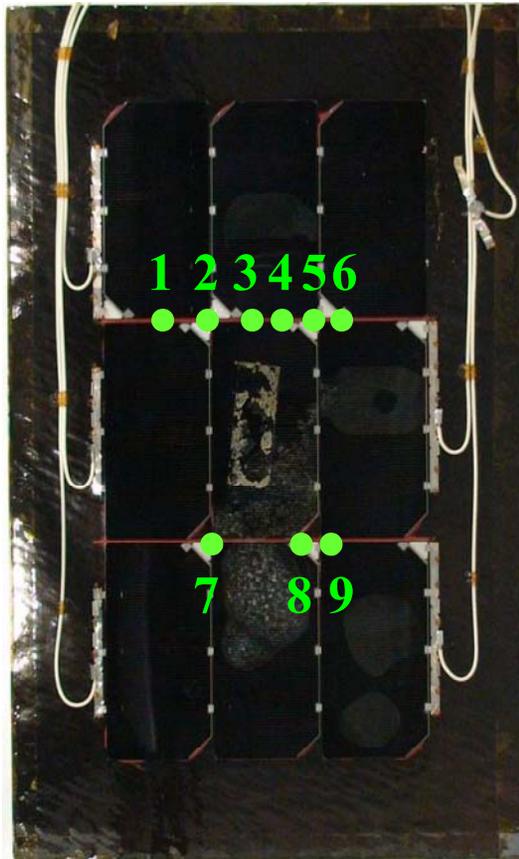
Photo of test coupon after simulated space environment test

● :Crack

Cracks were founded at the 9 points in total.

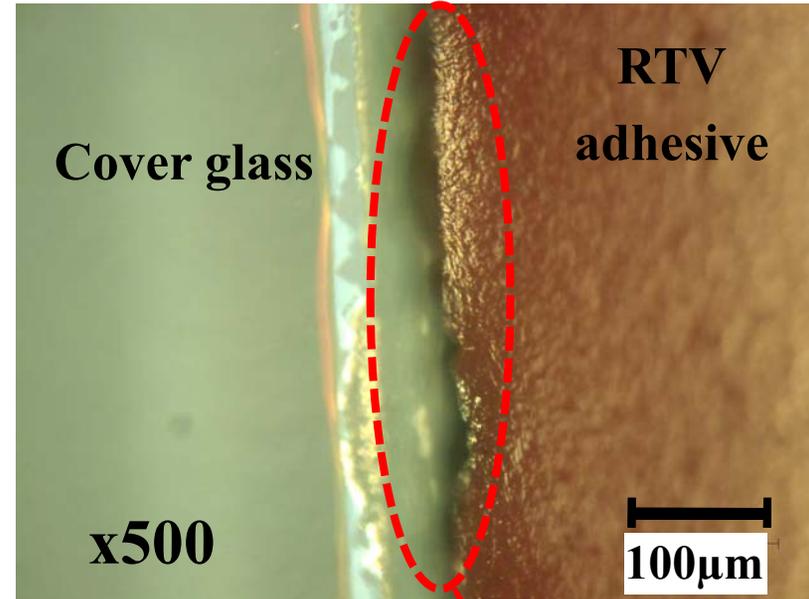
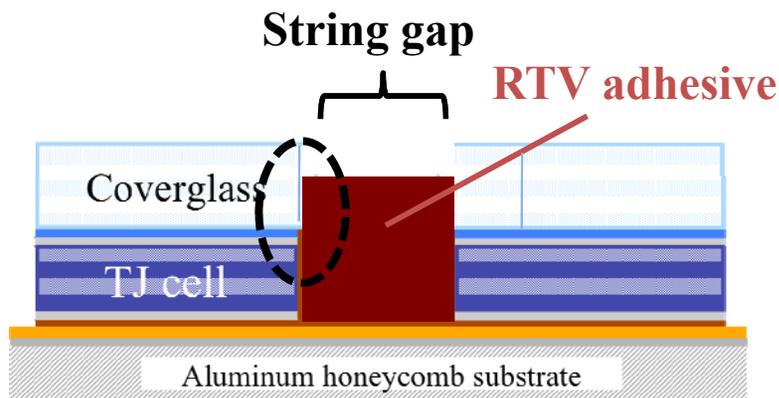
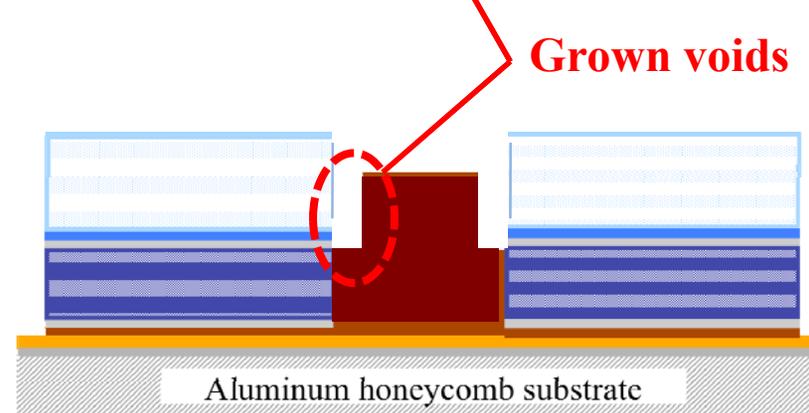
[After]

Growth of voids were found

at the interfaces between Cover glass and RTV-adhesive.

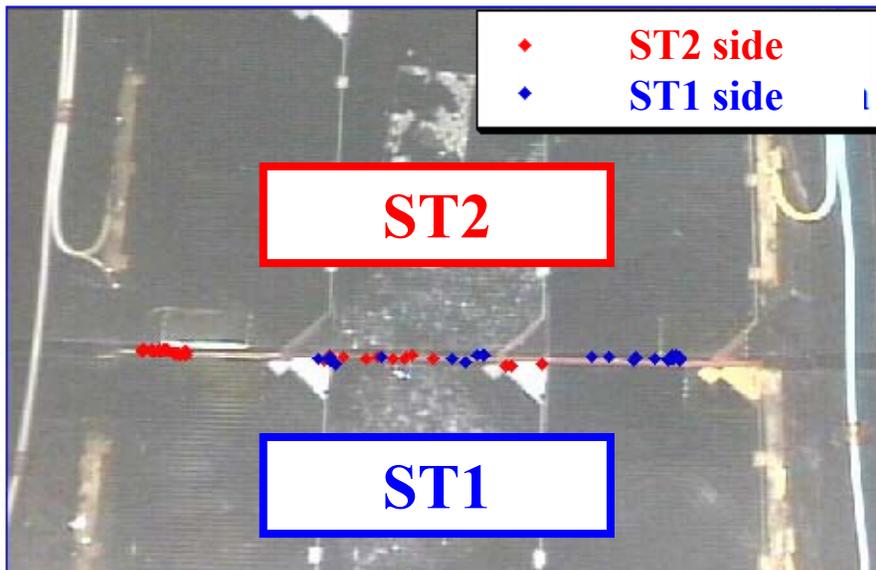
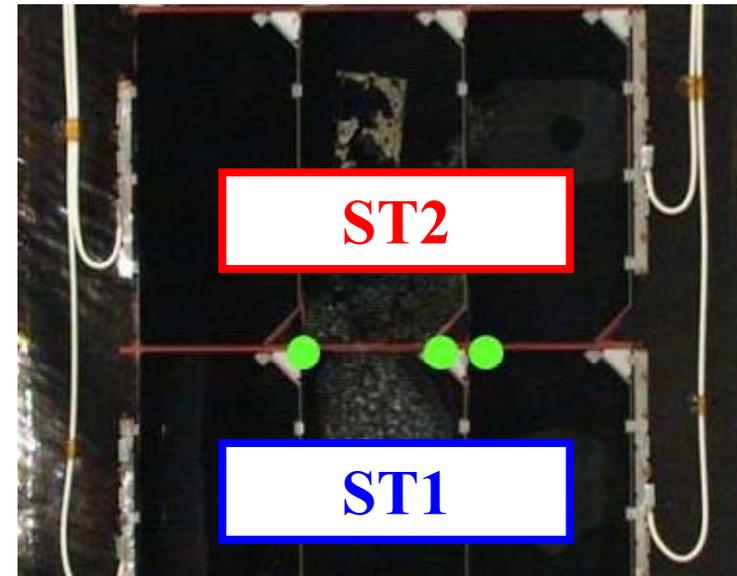
Number of Arcs	Position	
Total	ST2	ST1
97	64	33

● :Crack

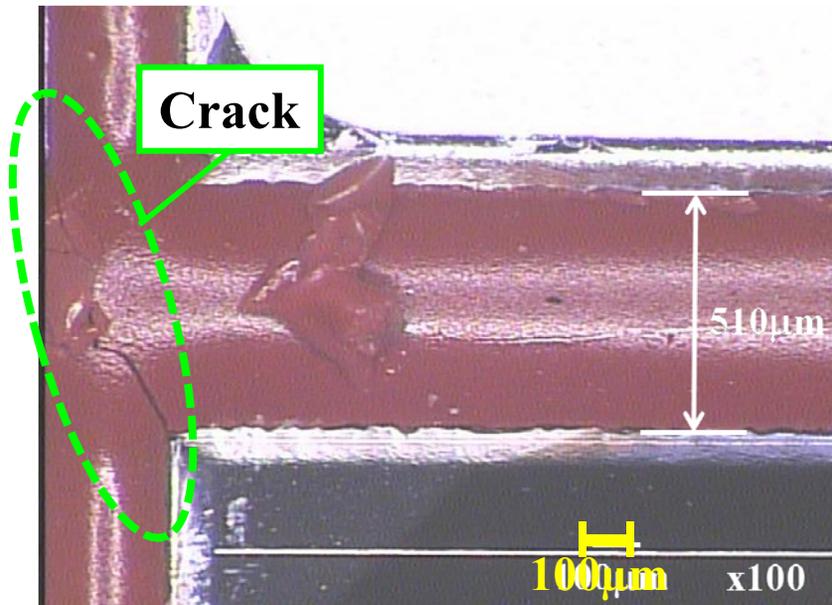
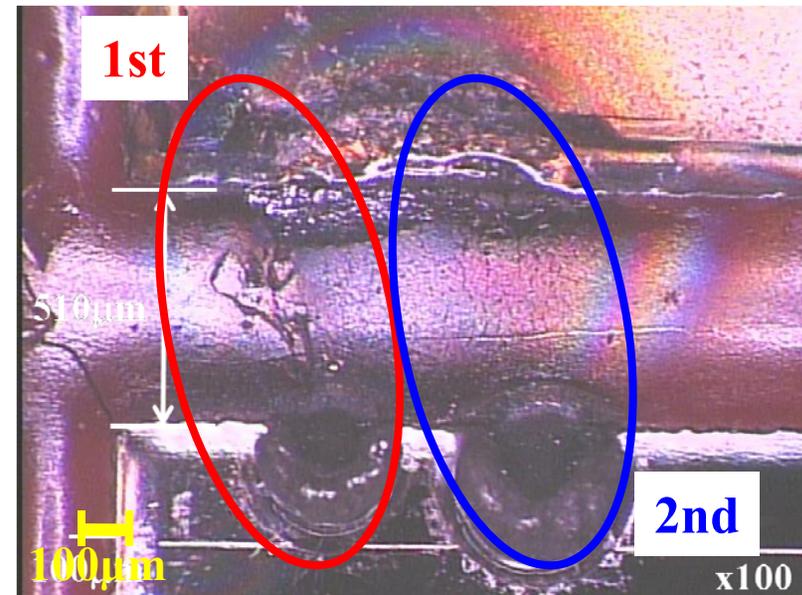
Trace of TSAs

2 TSA occurred outside the crack.

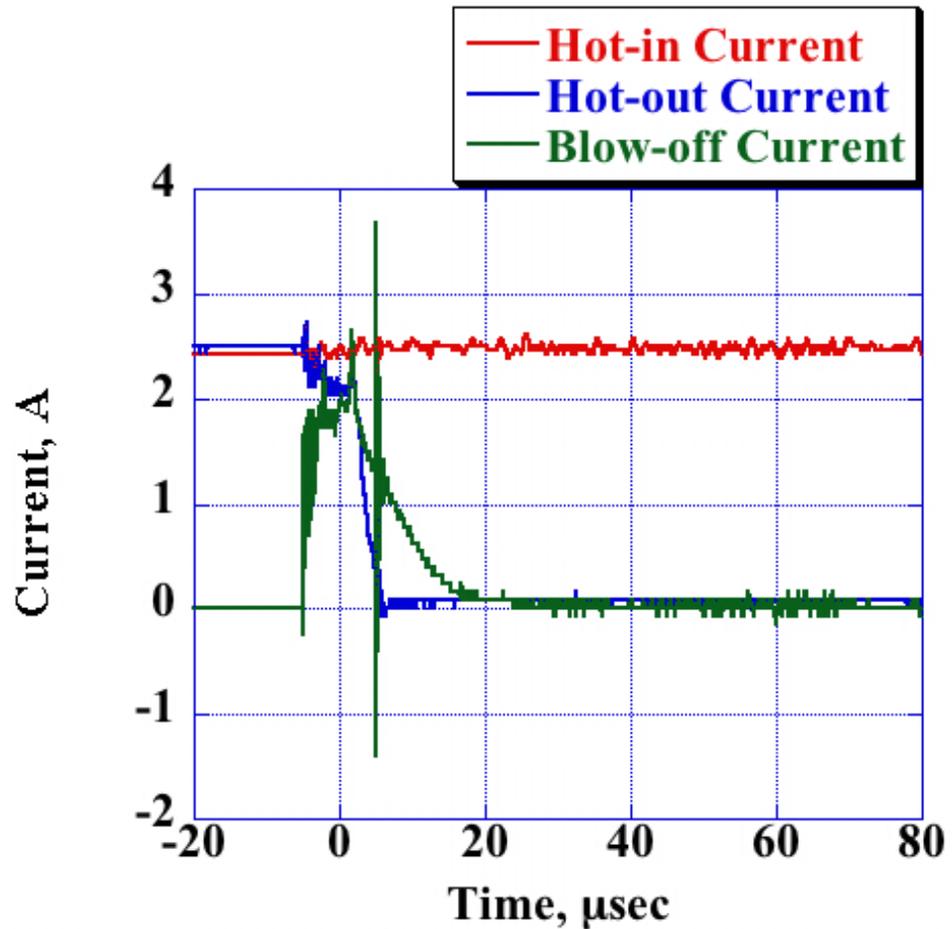
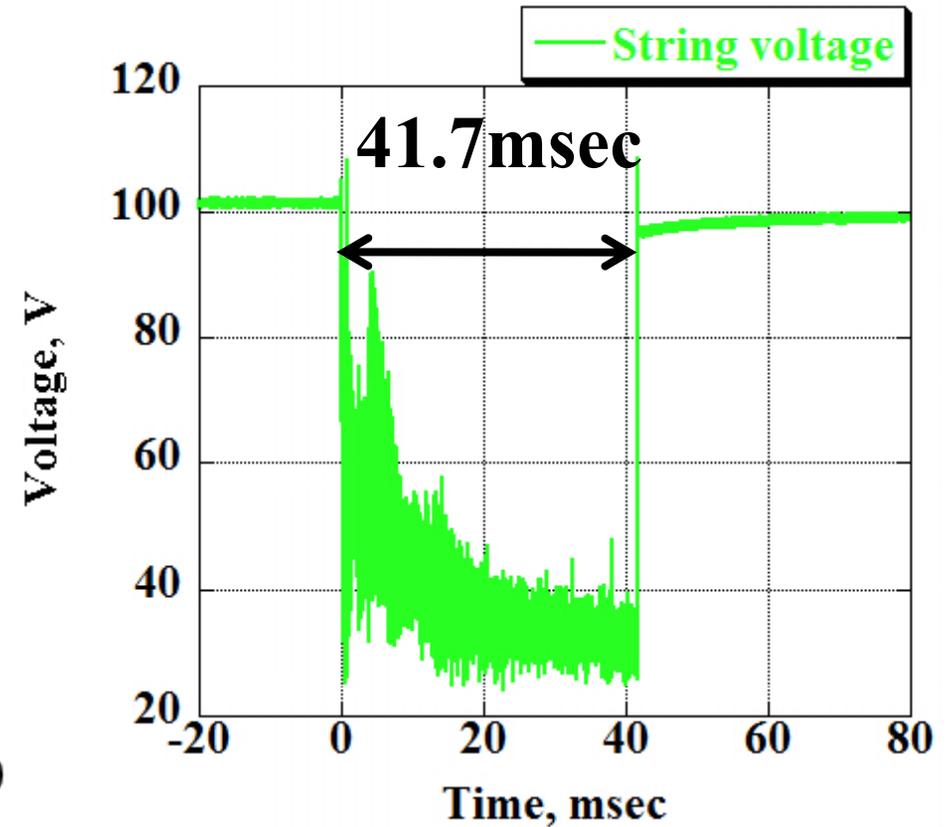
Waveforms of 1st TSA

Long duration was observed.

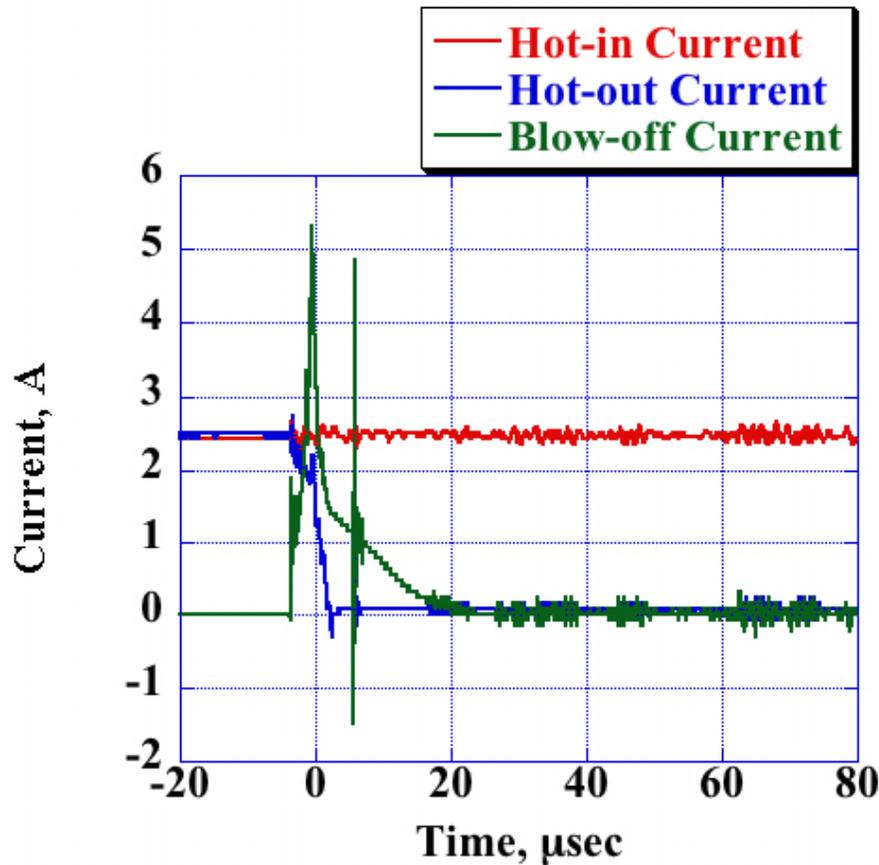
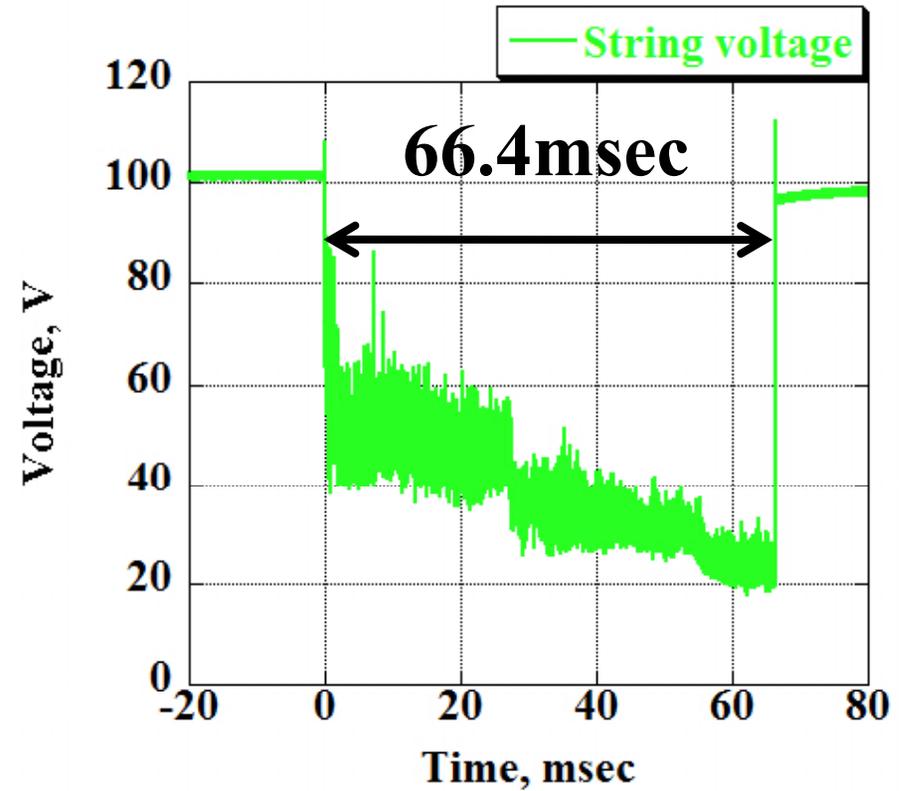
Waveforms of 2nd TSA

No effect of discharge on insulator resistance even though the duration were long.
