Introduction

Tsunamis in New Caledonia and Vanuatu

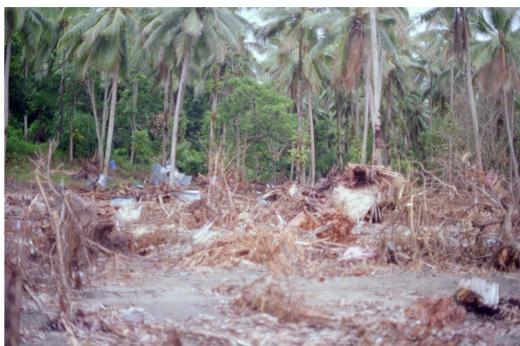
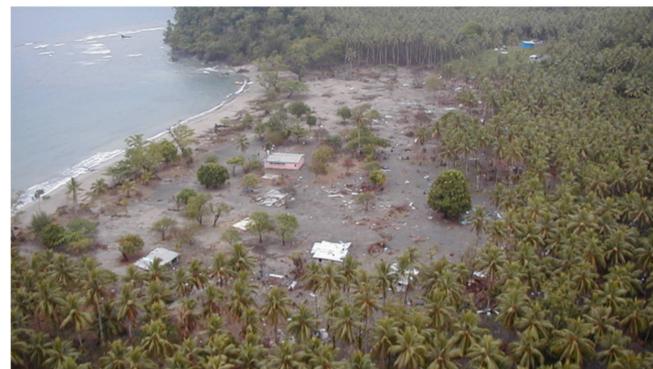
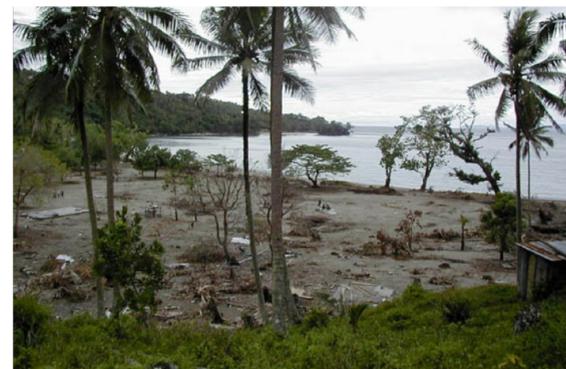
The village of Baie Martelli, Vanuatu, was destroyed after the 1999 tsunami. The large concrete village church (center image) was one of the few structures that remained standing following the tsunami. However, water surged over the top of the church (over 4 m above ground surface), crushing its corrugated metal roof. (Image Credits: Costas Synolakis (left), Utku Kanoglu (center, right))

The only other confirmed historical tsunami to cause deaths in the region occurred in 1999, generated on the previously described reverse fault in the back-arc of Vanuatu. The tsunami resulted in a 6.6 meter wave and five deaths at Baie Martelli, Vanuatu, though the death toll could have been much higher had it not been for indigenous knowledge as well as public outreach conducted three weeks prior by the Vanuatu National Disaster Management Office. The highest historical tsunami wave runup in Vanuatu is 12 meters on Tanna Island generated by a nearby earthquake in 1878.
